Manhole Inspection Summary

Manhole # S37A__009MH

Insp Date: **8/22/08 3:24 PM**

Location Address: **550 n high st**

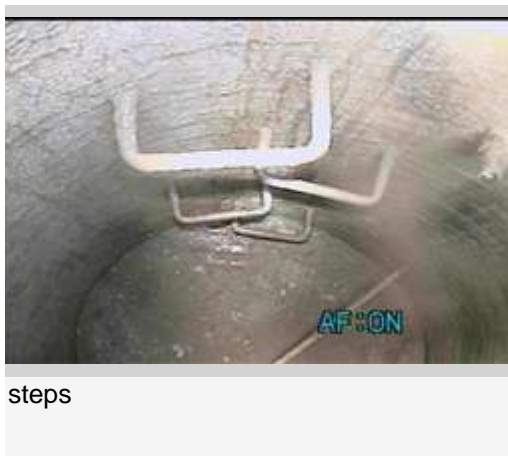
Defect 3

Count: **5** Missing: **0** ☒ **Corroded**

steps

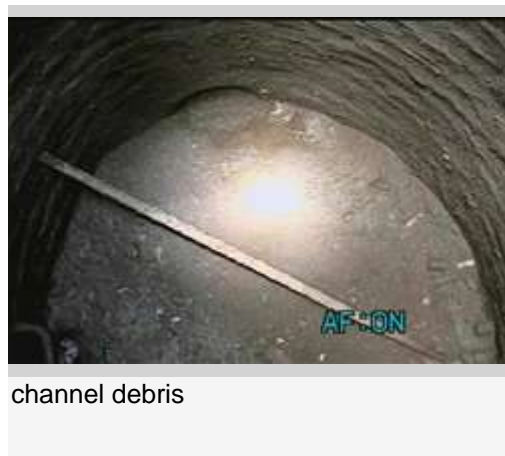
Defect 2

Condition: ☐ Sound ☐ Cracked ☐ Root Intrusion ☐ Deteriorated ☐ Leaks ☒ **Debris**

channel debris

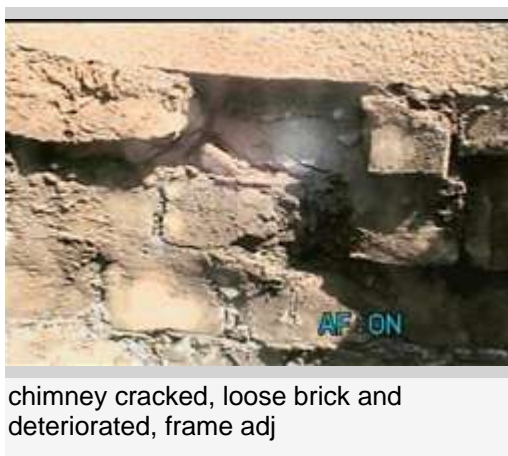
Defect 1

Condition: ☐ Sound ☒ **Cracked** ☐ Root Intrusion ☒ **Loose Brick** ☒ **Deteriorated**

chimney cracked, loose brick and deteriorated, frame adj
